12-TF-0009

**IONIC CONDUCTIVITY ASSESSMENT REPORT, RPP-ASMT-51526**

**TRI-PARTY AGREEMENT TARGET DATE  
M45-91F-T-03  
IONIC CONDUCTIVITY ASSESSMENT**

### **Through-Tank Ionic Conductivity Measurement Feasibility Study**

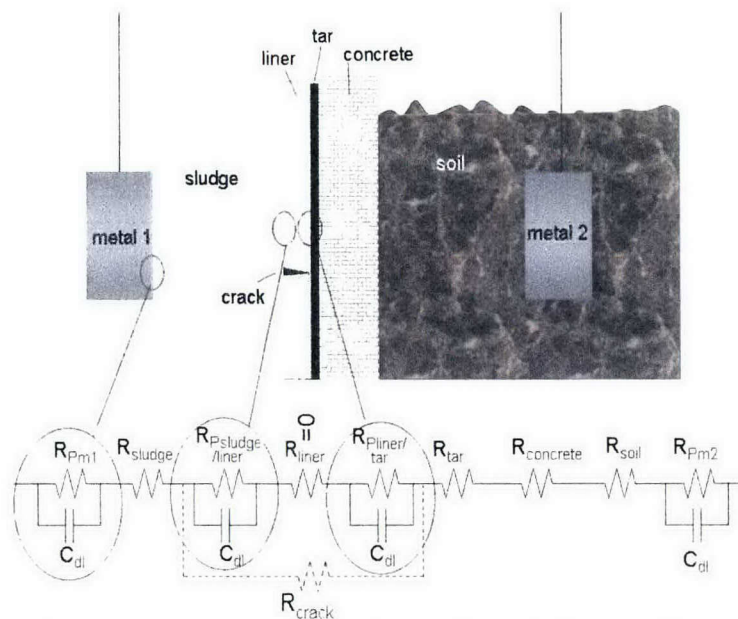
It is reasonable to assume that a good electrical connection could be made between a metal probe immersed in the tank sludge or saltcake (labeled Metal 1 in Figure 1) and a resistance meter such that the resistance along that connection would be essentially zero. A resistance exists across the metal/sludge interface. In fact, an equivalent electrical circuit consisting of a parallel resistor and capacitor can represent the electrical response of many electrode/electrolyte interfaces. The resistance, called polarization resistance ( $R_p$ ), is inversely proportional to the rate of the electrochemical reaction. If the metal electrode is corroding, then the polarization resistance is a measure of the corrosion rate. The capacitance is associated with the electrical double layer that sets up at this interface and is called the double layer capacitance.

Following the electrical path to the right in Figure 1, the ionic current would flow through the sludge or saltcake (indicated in Figure 1 as sludge for simplicity) until reaching the next barrier, the tank liner. Transport resistance through the sludge can be represented by a resistor, the value of which,  $R_{\text{sludge}}$ , would depend on the resistivity of the sludge and the geometry of the current flow (length and cross-sectional area). Assuming that the tank liner is intact with no ionic pathway connected with a through-crack, the ionic current would have to convert to electrical current at the sludge/liner interface. This interface can be represented by another parallel resistor and capacitor as shown in Figure 1. The electrochemical reaction at this interface (passive dissolution of the tank metal) would convert the ionic current back to an electronic current, which would flow through the tank metal. The resistance associated with this current,  $R_{\text{liner}}$ , would be essentially zero. The current would then be converted back to ionic current at the outer surface of the liner.

**Figure 1: Schematic of a system to measure ionic pathways. Expanded image of the current path segments between a metal electrode in a tank and one in the ground including an equivalent circuit.**

If the liner is breached by a through-wall defect that is ionically-conductive, then it is possible for part of the equivalent circuit in Figure 1 to be shorted. At a minimum the defect would short the two liner interfaces and it might also short the tar layer. If the resistance of the defect were low compared to the

EIS is a practical technique that has wide application. However, there are several unknowns and possible artifacts that could complicate the measurement. The values of the circuit elements shown in Figure 1 are unknown so that it is not clear if the resistance or impedance of a cracked liner would be different than that of a sound liner. It should be noted the area normalized resistance associated with the polarization resistance of an electrochemical interface has dimensions of  $\Omega\text{-cm}^2$  and the resistance of the full exposed area is determined by dividing this value by the area. For a large tank, this would result in a low resistance. The stray capacitance associated with long lead wires also can create problems with this measurement.

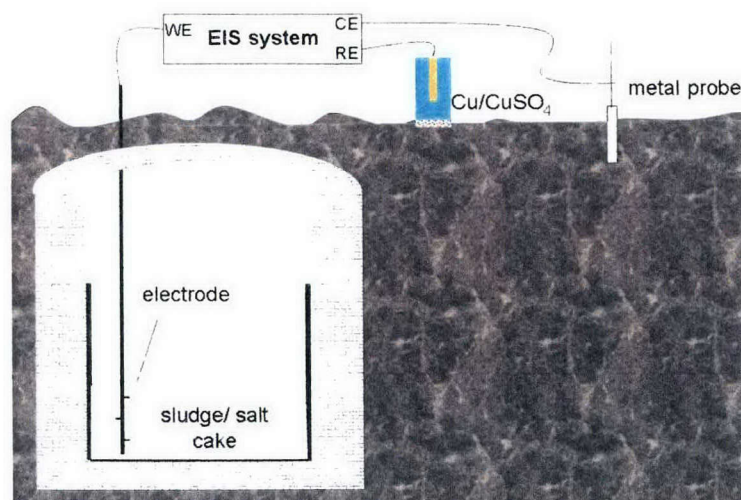
**Figure 2: Schematic of an EIS system to measure ionic pathways.**

As a result, the EIS response of an electrode immersed in a tank with reference and counter electrodes placed outside the tank (Figure 2) should provide information about the existence of any through-wall defect in the liner. However, it would only sense defects below the level of the sludge or saltcake. On the other hand, such a technique might be useful during retrieval operations to sense for leaks through cracks above the sludge top surface layer as liquid is sluiced into the tank. If a change in the impedance response were sensed during retrieval, operations could be shut down to prevent leakage.

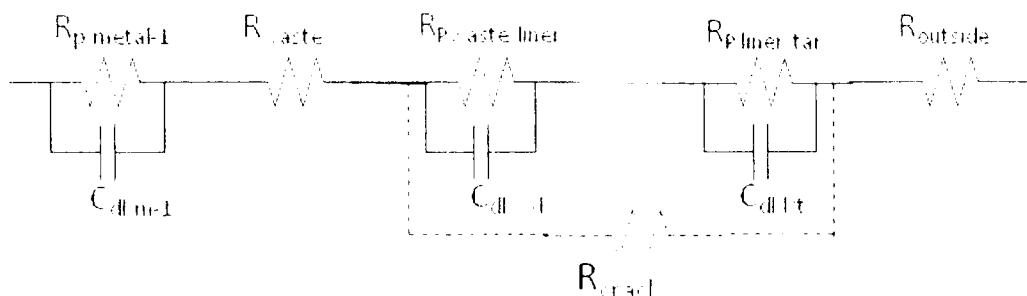
A modified version of the circuit shown in Figure 1 was used. As shown in Figure 3, several simplifications were made. The resistance associated with the liner was considered to be extremely small and was ignored. For simplicity, the circuit to the right of the liner/tar interface was combined into one resistance,  $R_{outside}$ . Also, note that the term waste is used to represent the contents, which can be sludge and/or salt cake.

**Figure 3:** Equivalent circuit used to model SST.  $R_{p,metal-1}$  and  $C_{dl,metal-1}$  represent the polarization resistance and double layer capacitance of the electrode immersed in the tank.  $R_{p,waste/liner}$  and  $C_{dl,waste/liner}$  represent the polarization resistance and double layer capacitance of the waste/liner interface,  $R_{p,liner/tar}$  and  $C_{dl,liner/tar}$  represent the polarization resistance and double layer capacitance of the liner/tar interface,  $R_{waste}$  represents the resistance of the waste,  $R_{outside}$  represents the impedance of everything outside of the liner, and  $R_{crack}$ , which is only present when modeling cracked tanks, represents the resistance of current flow to and through the crack.

flowing from the waste to a crack and then out into the surrounding ground. Therefore, the resistance noted as  $R_{\text{crack}}$  was actually the sum of three resistances: that associated with concentration of current from the waste to the crack, that associated with flow of current through the crack, and that associated with spreading of current from the crack to the outside of the liner. The primary resistance of a rectangular electrode of width  $w$  and height  $h$  in a solution of resistivity  $\rho$  is  $(\rho/2\pi w)\ln(4w/h)$  and the resistance associated with the flow of current through a rectangular slot of width  $w$ , height  $h$ , and length  $l$  is  $\rho l/wh$ . Note for a crack in a liner that  $l$  would be the liner thickness. Therefore, the value used for crack resistance was:

$$R_{\text{crack}} = (\rho_{\text{waste}}/2\pi w)\ln(4w/h) + \rho_{\text{crack}}l/wh + (\rho_{\text{outside}}/2\pi w)\ln(4w/h) \quad (1)$$

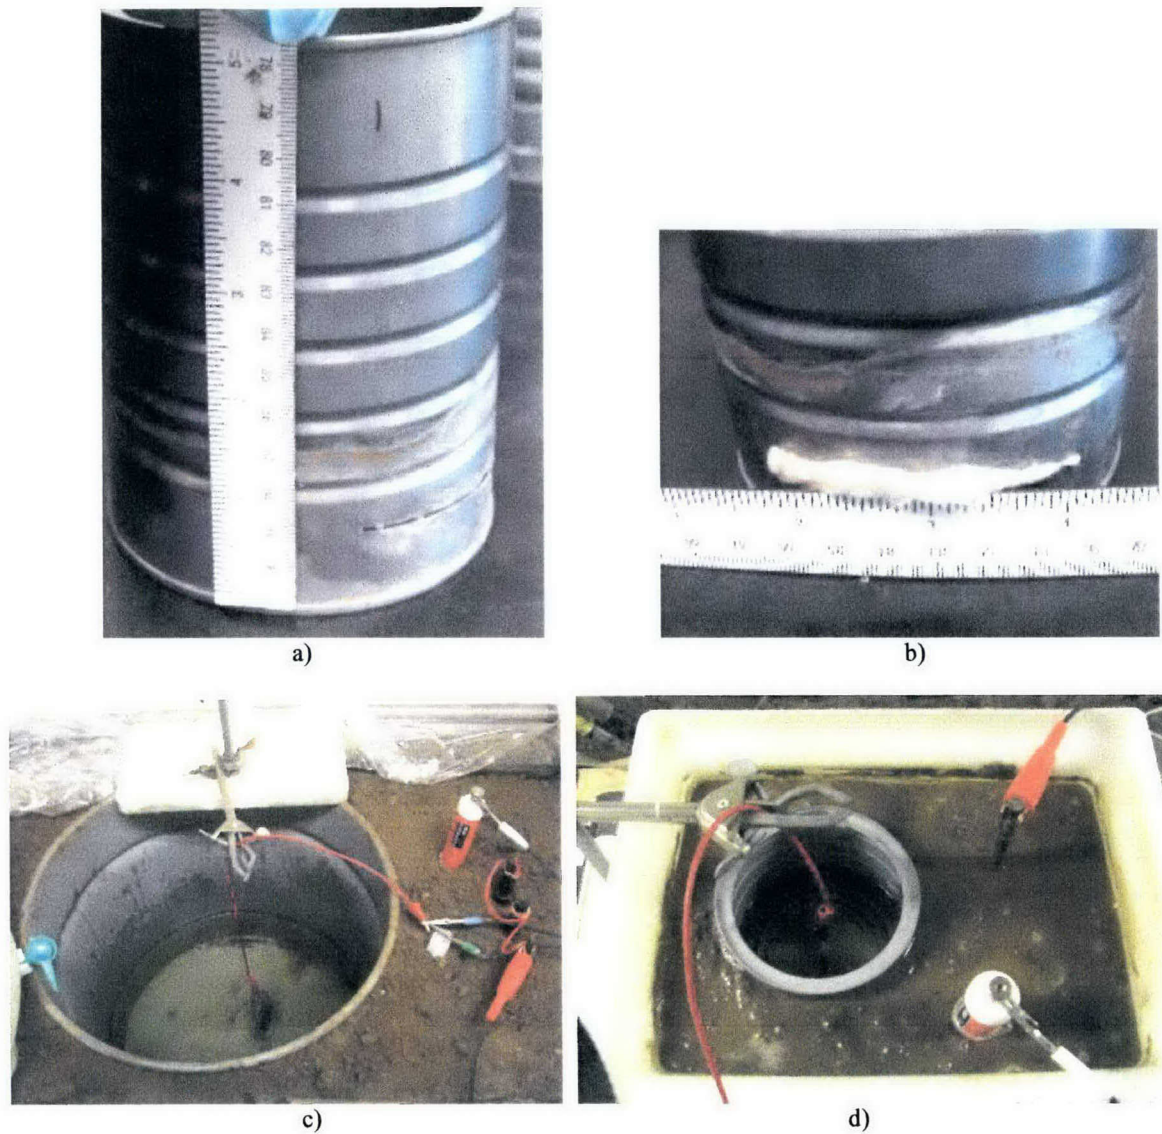
Figure 8: Images of cans used in Phase 2. a) exterior of 4 in diameter can after cutting slot; b) Slot with cotton stuffed in; c) 6 in diameter can embedded in soil showing reference and counter electrodes in soil; d) 4 in diameter can in soil.

Lab bench scale models were constructed using steel coffee cans, which were stripped of any organic layer protection and tinplate, as a tank analog. Two cans with different diameters were used: 4 and 6 in. The waste was modeled using a concentrated high pH nitrate solution similar to the simulants that have been used in the DST testing at DNV. Soil was used outside of the can. Experiments were performed with openings of different sizes machined into the can. Electrochemical measurements were performed to test for sensitivity to the defects. The equivalent circuit model from Task 1 was utilized to compare with the results as a model validation exercise.

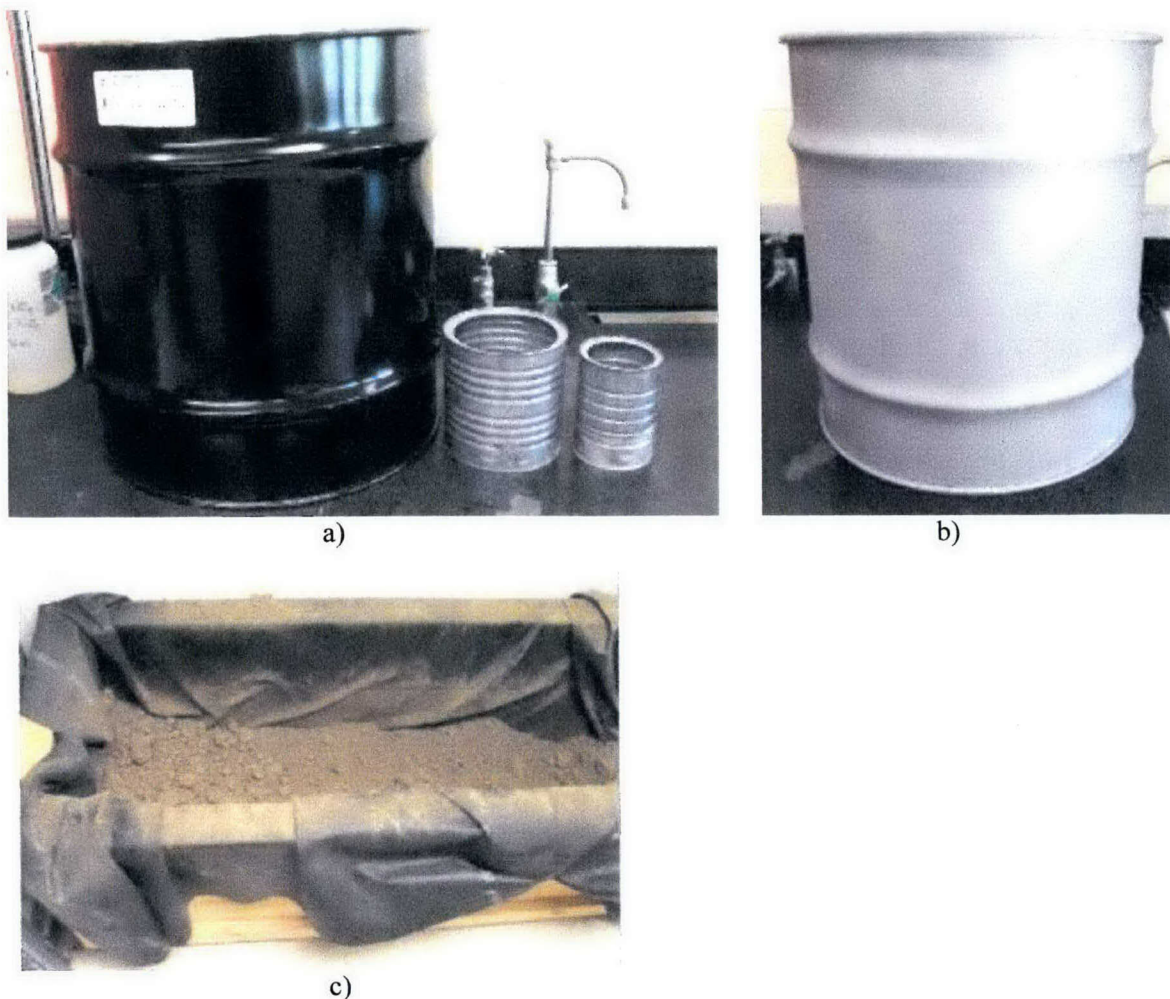
To further test the effect of area ratio with a yet larger can, a 26 gallon (20 in height by 19 in diameter) can was buried in a soil box in the basement of DNV labs. The dimensions of the soil box were 35 in long (only half of the length was used, the total was 70 in) by 21 in wide by 24 in deep, which contained 10.2 cubic feet of soil. Images of the large can and soil box and large can are shown in Figure 11. It was determined that using a soil box instead of burying the can outside was advantageous because it gave better control over moisture/soil resistivity and it was easier to prevent contaminants (rain water, dust, etc.) from entering the can. The resistance of the soil in the soil box was measured using a Nilsson Soil Resistance Meter (Model 400) and was found to be 1400 to 1700 ohm-cm, which is higher than the resistance of the soil used in Phase 2.

Figure 11: Images of setup in Phase 3; a) 26 gal can tested in Phase 3 next to cans tested in Phase 2; b) 26 gal can after sand blasting; c) soil box used for large can testing.

The coatings on the outside and inside of the large drum were stripped to expose the carbon steel surfaces by sand blasting using 60 grit aluminum oxide media. The solution chemistry was changed for these tests from 5 M  $\text{NaNO}_3$  + 5 M  $\text{NaNO}_2$  solution at pH 12 to 1 M  $\text{NaNO}_3$  + 1 M  $\text{NaNO}_2$  at pH 12 to reduce the amount of chemicals required for solution preparation. EIS tests were conducted on the medium can with this new chemistry to verify that the transition to the new chemistry did not significantly alter the results.

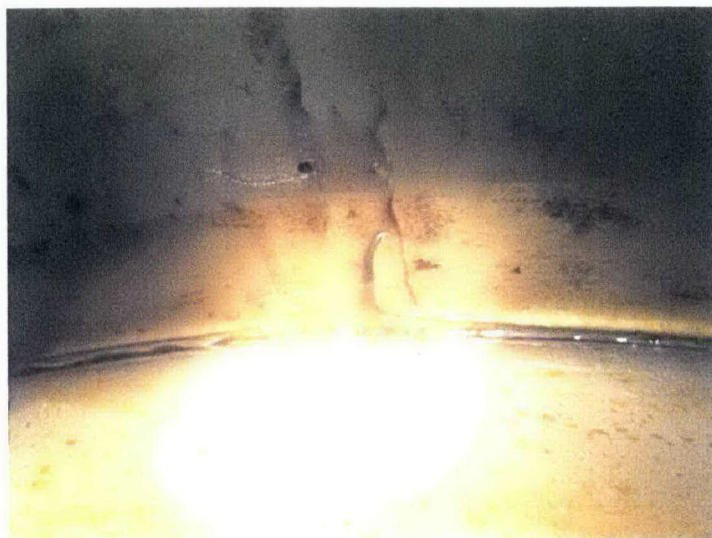
electrodes were situated. The hole was sealed with Hardman® DOUBLE/BUBBLE Extra-Fast Set epoxy to reuse the can for replicate experiments. After creation of the hole, the can was allowed to leak for 12 h and then the foil was inserted and testing was initiated.

Figure 12: Image of the hole created in the 26 gal can. This picture was taken after epoxy was applied to cover the hole for repeated sound can testing.

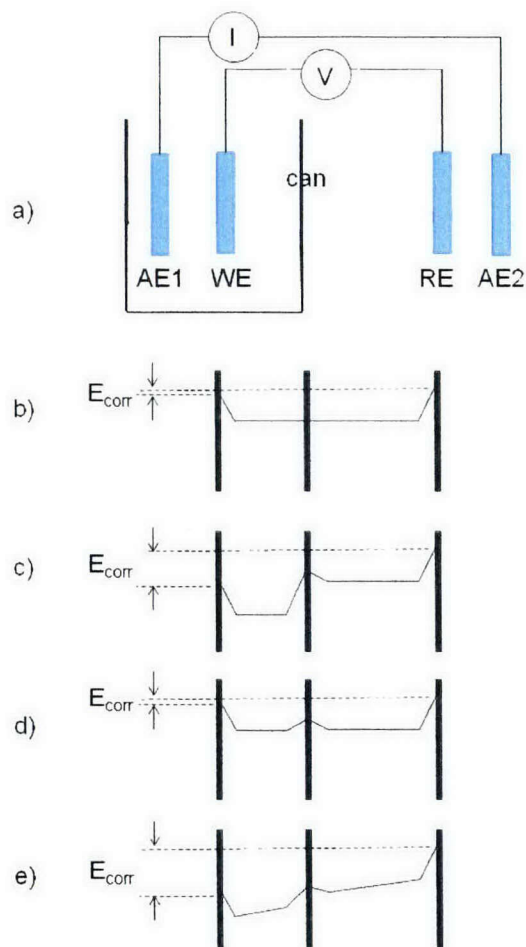
For the case where the working electrode and reference electrode are separated by a sound metal container such as the tank liner or a can wall, two more potential components must be considered. On the inside and outside interfaces of the metal container (interfaces with the waste and concrete, respectively, for a SST), there will be potential drops associated with the respective OCPs in those environments. This is shown schematically in Figure 15c for the case where the two OCPs (inside and outside) are different. The difference in the two OCPs will be added to the total potential difference measured between the reference electrode and working electrode as shown in Figure 15c. This schematic representation explains why the OCP of the Al working electrode was different for a sound drum and the drum with a hole, and suggests that a simple OCP measurement between an electrode in the waste and a reference electrode in the soil could be a diagnostic indicator of the presence of a hole.

Figure 15: Schematic representations of potential measurement approach: a) layout of electrodes inside and outside of can; WE = Al working electrode inside can, RE = reference electrode outside can, AE1 = auxiliary electrode inside can, AE2 = auxiliary electrode outside can, V = high impedance voltmeter, I = current supply; b) potential components between RE and WE for case where there is a hole in the can or tank (not applied current); c) potential components between RE and WE for case with hole and potential drops on the inside and outside of the can are not the same; d) potential components between RE and WE for case with no hole but the potential drops on the inside and outside of the can are the same; e) potential components when current applied between AE1 and AE2.

It might be possible to overcome the problems associated with unknown difference of the inside/outside potential by using two other electrodes to pass a current. Figure 15a shows how a current supply could be used to pass a current between two auxiliary electrodes located inside and outside the tank, respectively. The current would pass through tank, polarizing the inside and outside interfaces. This is represented in Figure 15e by changes in the sloped regions next to the can relative to the case shown in Figure 15d. There would also be an ohmic potential drop in the waste and soil owing to the current flow so the potential lines between the electrodes are sloped in Figure 15e. The corrosion potential under this condition thus has many components, including the ohmic potential drop, which complicates its analysis. However, if the applied current is interrupted, the ohmic potential drops vanish instantaneously, and the potential drops across the interfaces decay with time because of the capacitance of the interfaces. For the case of a tank with a defect, the current would flow through the defect and there would be no capacitive decay, because only ohmic potential drop would exist between the working and reference electrodes. It is possible that analysis of the potential after interruption will provide information about the soundness of the can/tank.

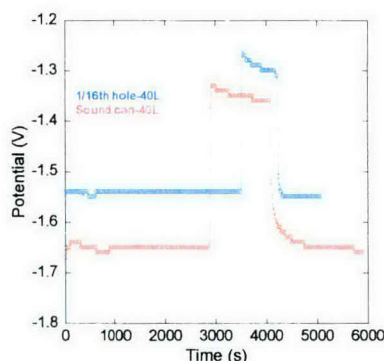
Figure 16 shows the results of the potential measurements. The corrosion potential of the Al working electrode is shown as a function of time for the sound drum and for the drum with a hole. The first values of potential are the OCP with no applied current in the system. There is a clear difference in potential of about 110 mV for the two cases. This difference in the two cases is the result of a different corrosion potential for the inside and outside of the sound drum. The increase in potential observed at about 3000 s is associated with turning on the current between the two auxiliary electrodes. As described above, the current both polarizes the can interfaces and causes an ohmic potential drop in the soil and solution, all of which results in a change in the measured OCP of the working electrode for both cases. The potential for the case with the hole increases by about 275 mV; whereas, for the case of the sound drum, the potential increases by about 300 mV. As the current is turned off at about 4500 s, the potential drops suddenly and then decays back to a value similar to the original OCP. The decay is slower for the sound drum than for the drum with a hole.

Figure 16: Measured corrosion potential of the Al WE inside the drum vs. the RE located in the soil for a sound drum and for a drum with a hole. During the period from about 3000-4500 s, a current was passed between two auxiliary electrodes located inside and outside the drum.

The corrosion or open circuit potential of the working electrode inside the tank relative to an external counter electrode was found to be different for a can with a defect compared with a sound can. This difference, which is the result of a difference in the corrosion potential of the can in the interior and exterior environments, can be used as a diagnostic assessment for the presence of a defect. The potential of an electrode relative to a reference electrode located inside a tank could be compared with the potential relative to a reference electrode outside the tank. If there were differences (accounting for any difference in the reference electrodes), it would indicate that the tank is sound. However, in the case where the interior and exterior tank liner corrosion potential is similar, a false positive is possible. In other words, the corrosion potential of the working electrode would be similar relative to the two reference electrodes even though there was no through-defect in the tank. In this regard it would be a conservative measure.
